DEPARTMENT OF DEFENCE DEFENCE SCIENCE AND TECHNOLOGY ORGANISATION AERONAUTICAL RESEARCH LABORATORIES

MECHANICAL ENGINEERING NOTE 363

VIBRATION INVESTIGATION OF HELICOPTER ENGINE COOLING FAN

March 1977

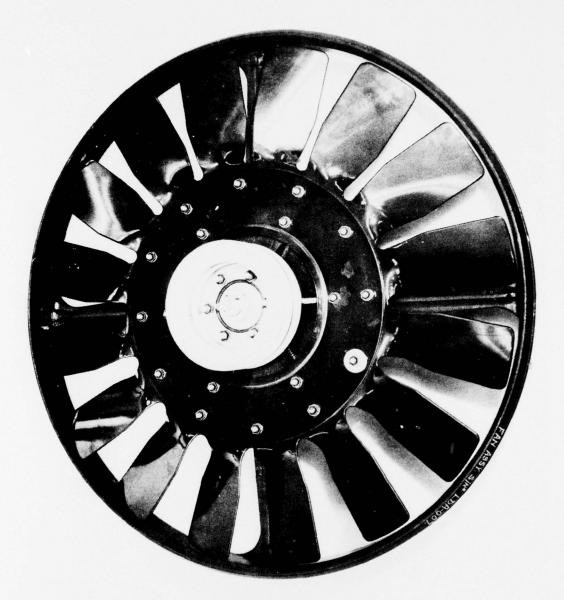
FIG. 1. THE COOLING FAN ASSEMBLY - FRONT FACE

The fan disc (Fig. 1) has 16 blades pressed from aluminium sheet. Originally three stiffening discs were bolted to the front face of the fan, with an outer circle of 12 bolts having load sharing washers bearing on the rear face of the fan disc, and an inner circle of 6 bolts which attached the assembly through a spacer to a cast aluminium hub. The fan is driven by twin V belts, the belt pulley being bolted separately to the hub, and has a normal operating speed of 4800 rpm.

In the period between mid 1969 and mid 1971 twelve fatigue failures of fan blades were reported, at times since overhaul between 99 and 590 hours. The fan is not "lifed" but assessed on condition at overhaul, and total lives generally are not known. In all but one of these cases, crack initiation was attributed to stress corrosion, the indentations of the washers in the rear of the fan disc proving a particular location of weakness. An investigation was undertaken by Hawker de Havilland in 1971 (Ref. 1), comprising essentially measurements on a stationary fan of principal natural frequency and damping, using impulse excitation. This led to a modification whereby two stiffening discs were fitted to each side of the fan, the inner discs being bonded to the fan and the outer ones bolted (to promote damping). The fan with four discs was then fitted to the hub without the original spacer.
